### Inspection Report

#### Minerals Regulatory Program

**Mine Name:** Black Ridge  
**Operator Name:** Thirstystone Resources, Inc.  
Pete Raymond  
860 East 19<sup>th</sup> Street  
Tucson, Arizona 85719-6615

**Permit number:** S/053/027  
**Date:** September 12, 2006  
**Time:** 4:45 PM

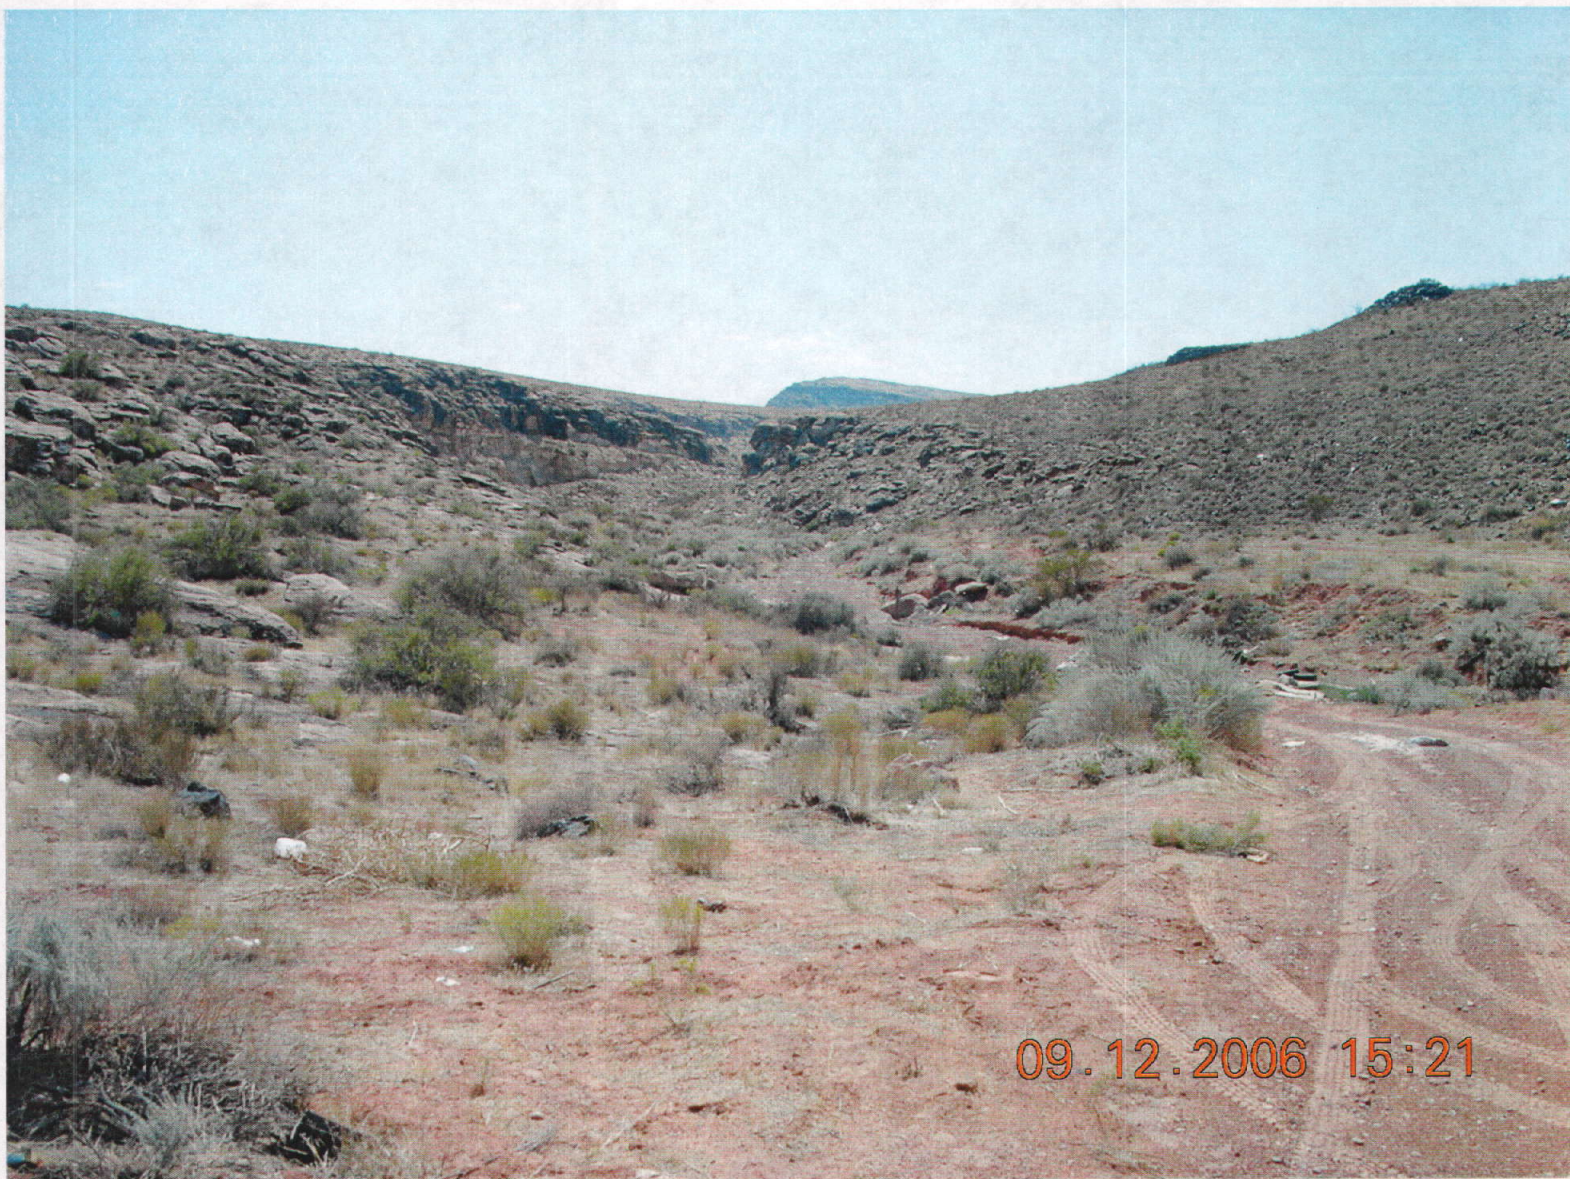
The site remains unchanged; this site has been inactive for four or five years. The road into the site is still washed out, no effort has been made to fix the road.

ROAD INTO SITE, QUARRY IN THE DISTANCE

Because this site has been inactive for at least four years, the operator should contemplate the reclamation.
